Quell QPI9010 Dual Sensor Smoke Alarm Recall Identification Guide

(for New Zealand sold units)

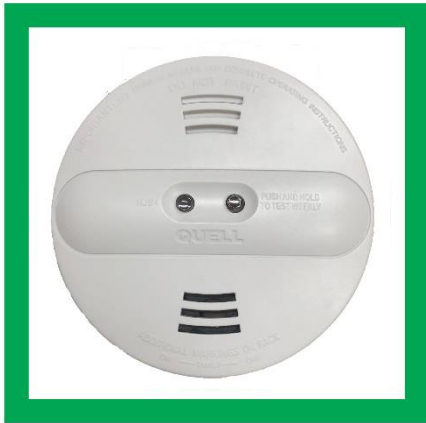
Affected

Look for this pill shaped design on the front of the unit. This feature is slightly raised and is unique to this alarm.

If your alarm matches this design, please proceed to the next step.

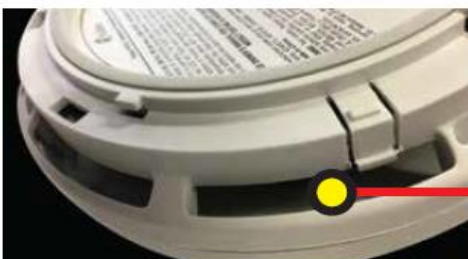
Not Affected

No yellow cap is visible. Unit is not affected.
